Masonry Performance and the World Trade Center Disaster

by David T. Biggs, P.E.

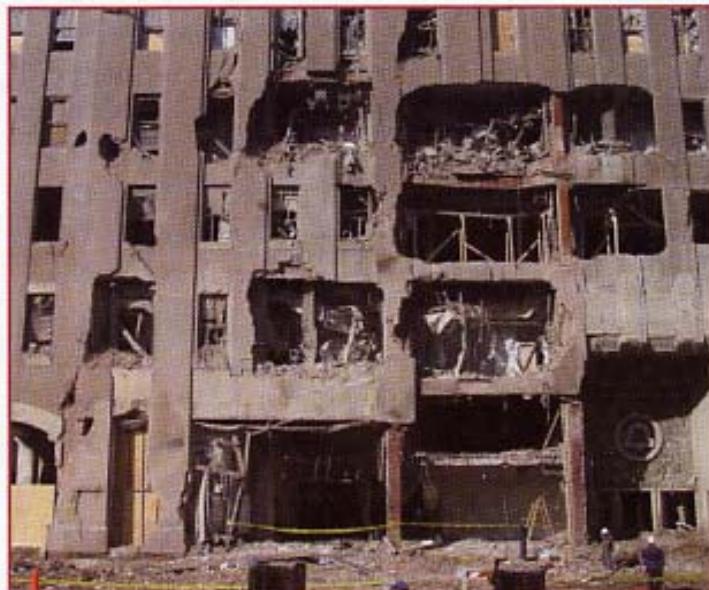
Figure 2. East elevation of 140 West Street.

- Framed buildings with exterior masonry walls generally performed better than newer buildings with lightweight curtain-wall construction. Figure 2 shows the east wall of 140 West Street, which faces #7

building. Large portions of the exterior wall were damaged, but the damage remained confined to the area of impact. Figure 3 shows the Banker's Trust building. A column tree from the south tower sliced through the curtain wall system and structure from the 15th floor down to the 8th floor. It is not fair to assume both buildings experienced the same loading. In general, however, the masonry elements of buildings that were impacted absorbed the impact energy and limited the damage.

- Masonry infill for walls and beams functioned as fire-proofing and provided significant structural redundancy. The infill provided an alternate load path to transfer gravity loads from damaged steel columns and prevented the collapse of portions of several buildings. Figure 2 is also an example of this.

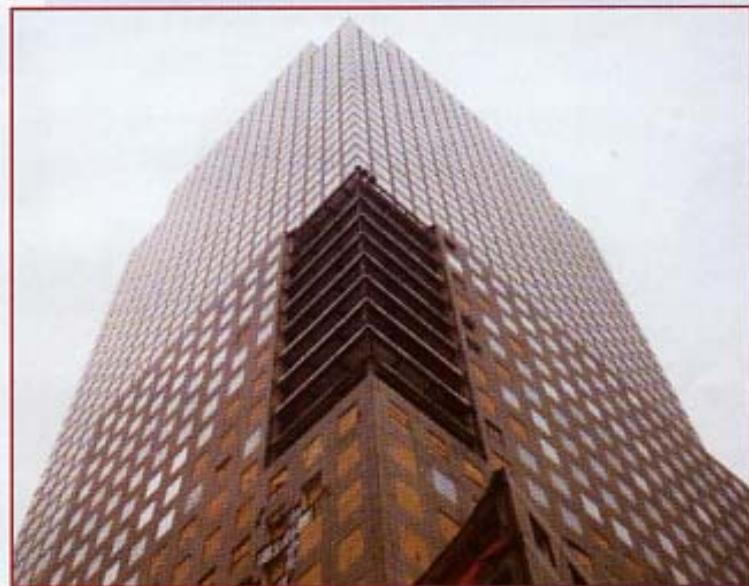
Figure 4. Southeast corner of #3 World Financial Center.

- Interior masonry partition walls provided redundant lateral stiffness and added fire protection in the older buildings.
- The performance of masonry veneers and panelized masonry systems was dependent upon the type of veneer and the anchorage system used. Figure 4 shows where damaged wall panels with granite facing were removed and later rebuilt.

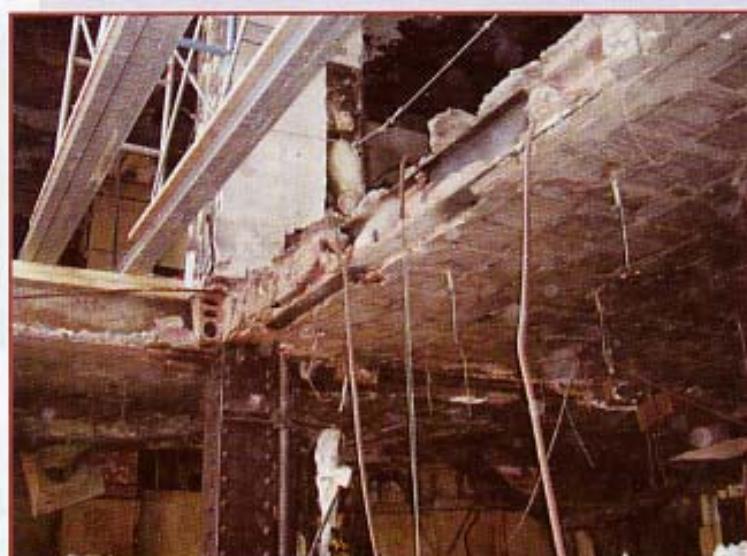
Figure 5. Flat arch tile floors in 90 West Street.

- The masonry flat arch floors of 90 West Street performed better under fire conditions than the newer steel-framed plaza buildings that could be examined. Figure 5 shows a section of floor in 90 West Street adjacent to an impact area. Built to 1906 standards, it remained intact after the fire. Figure 6 shows a section of distorted steel framing in plaza #5 building, which was designed and fireproofed using 1970 standards. While both areas experienced a full fire burn, the masonry construction performed better.
