Masonry Performance and the World Trade Center Disaster

by David T. Biggs, P.E.

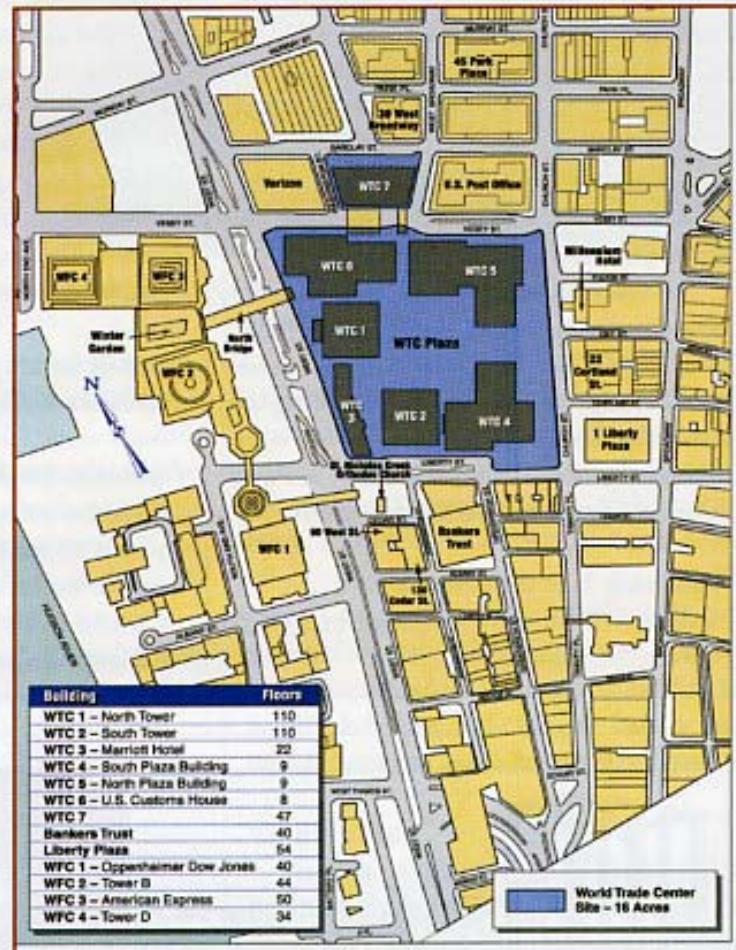
The primary emphasis of the BPAT report was the collapse of the two 110-story office towers and a third 47-story office building (#7 building) at the World Trade Center Plaza (Figure 1). The towers collapsed within two hours of being attacked, and the third building collapsed later that afternoon as an apparent result of fire damage. The BPAT report was intended as an initial assessment and was not expected to serve as the definitive analysis. The National Institute of Standards and Technology (NIST) is in the process of extending the study.

Figure 1. World Trade Center Plaza and surrounding buildings.
